**Evaluation of Public Safety at Run-of-River Dams
An Illinois State Wide Program**

JULY 20, 2007

APPENDIX V – Dam Investigations

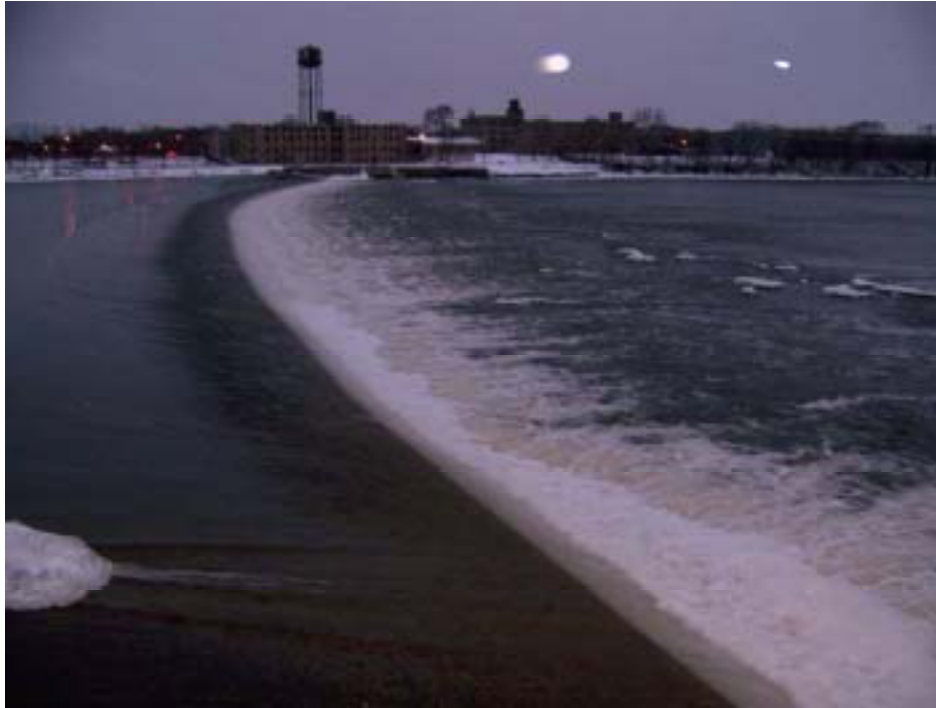
Photo 5.2.3.2 - 1 - Lower Sterling Dam, Rock River
Roller extends over 15' d/s from toe of dam.

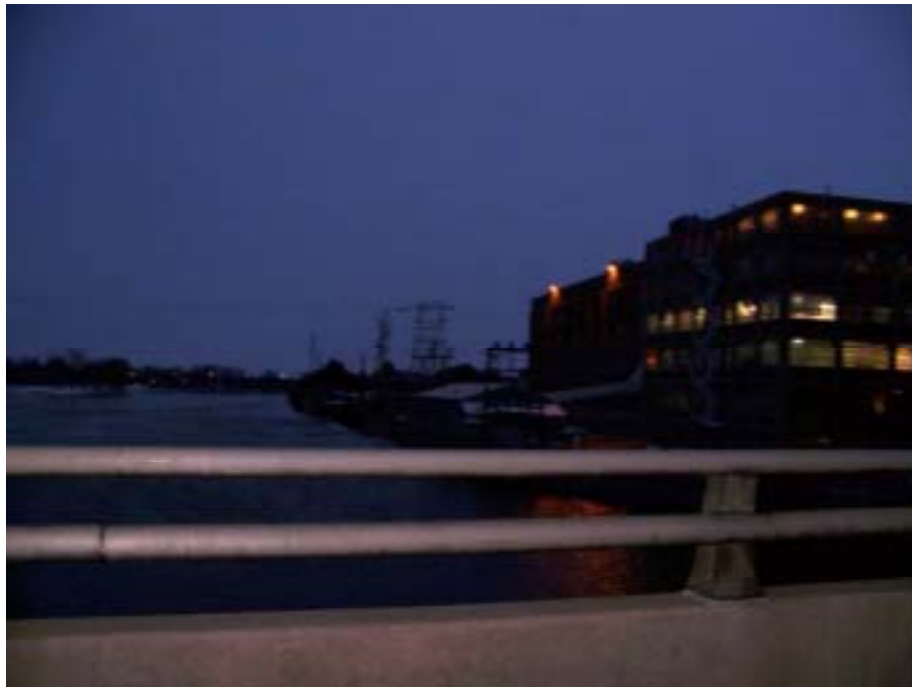
Photo 5.2.3.2 - 2 - Lower Sterling Dam, Rock River
Looking d/s at right abutment; note bulkhead riverbank, no access possible from right bank.

- 1) Lack of guard rails on right abutment.
- 2) Lack of a portage on either side of the river. The only feasible portage would be on the L/B; would require negotiating fairly steep embankment u/s consisting of large riprap. Portage required is long to circumnavigate dam and long abutment structure.
- 3) Lack of signage concerning the roller hazard.

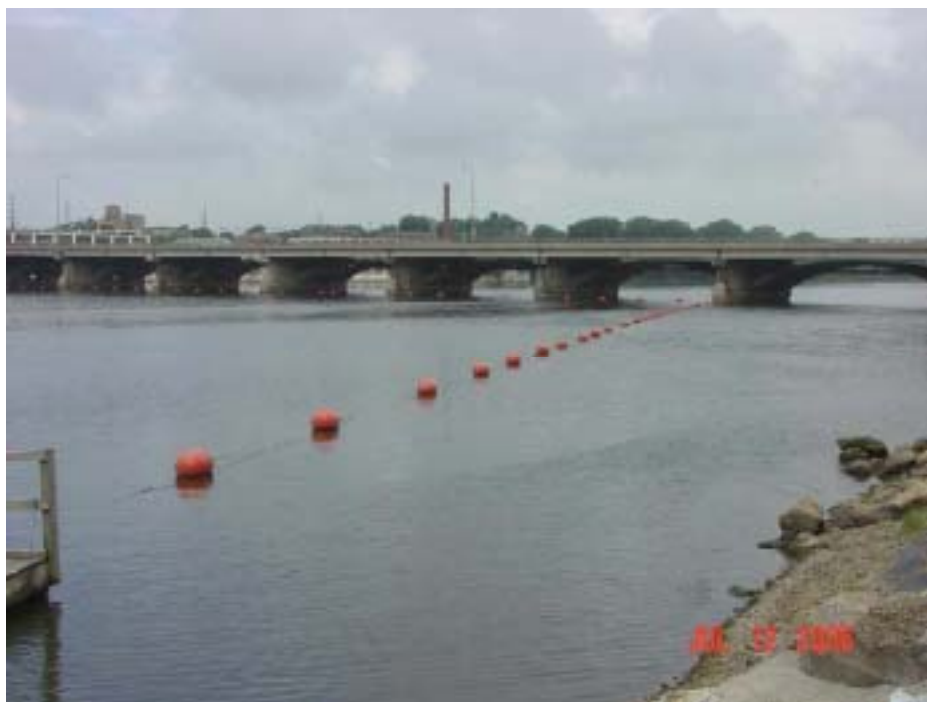
Photo 5.2.3.2 - 3 - Lower Sterling Dam, Rock River
Boatline, from Left Bank. (IDNR, 2006)

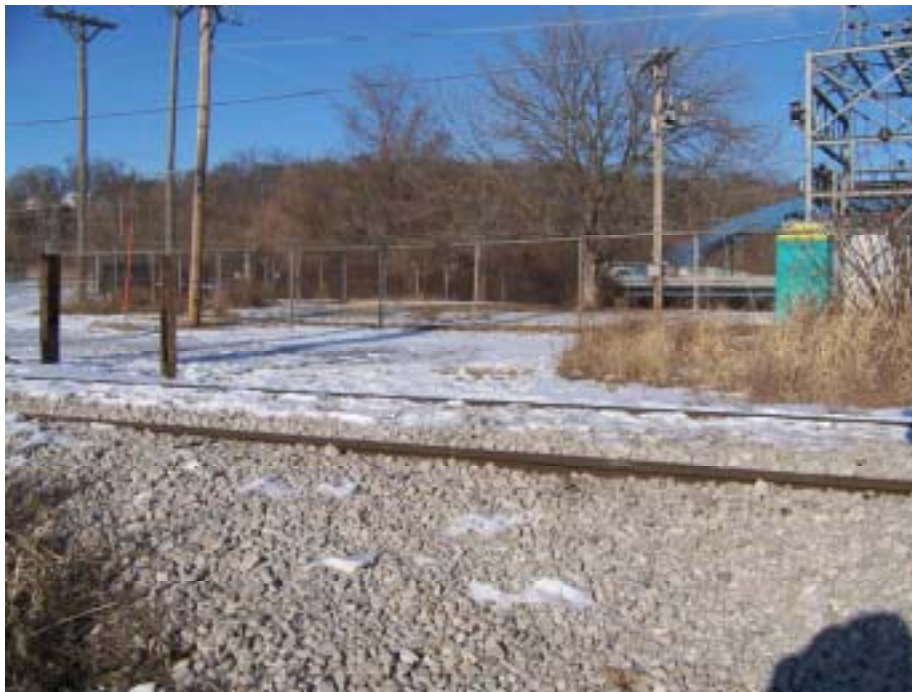
Photo 5.2.4.2 – 2 – Sears Dam, Rock River

Looking u/s along right bank portage must cross tracks, circumnavigate fenced area and wetland.

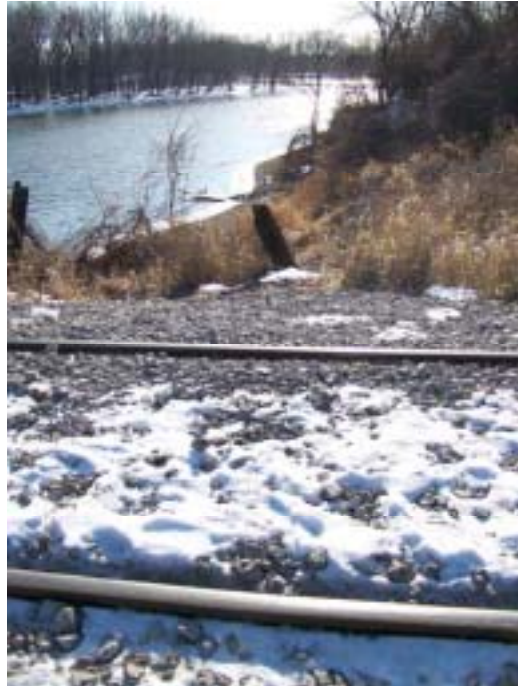
Photo 5.2.4.2 – 3 – Sears Dam, Rock River
Looking d/s right bank portage

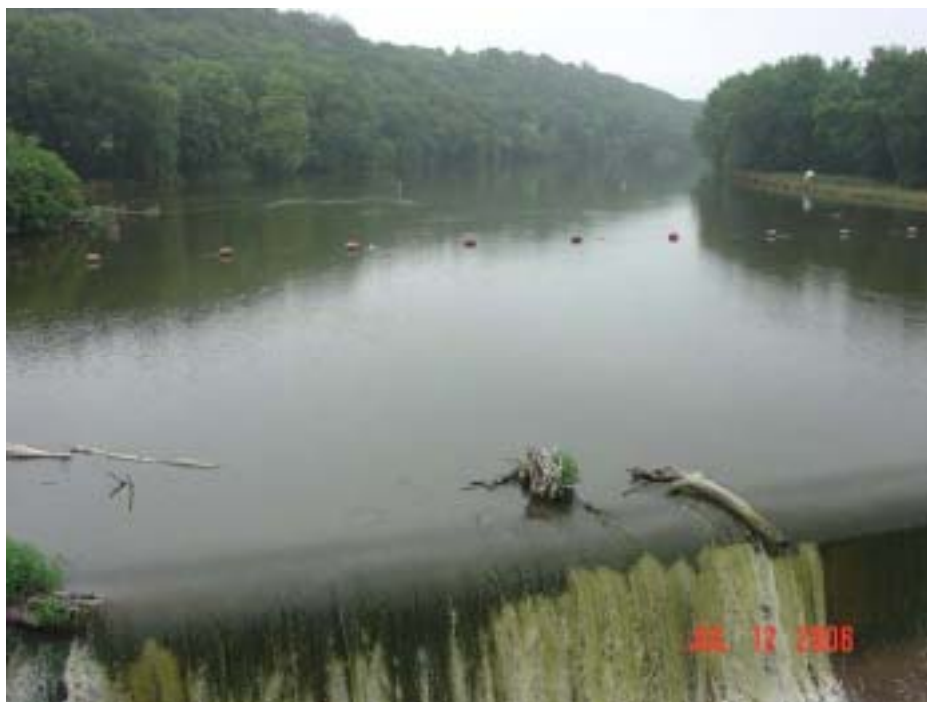
Photo 5.2.4.2 – 5 – Sears Dam, Rock River
Boatline and Dam Face (IDNR, 2006)

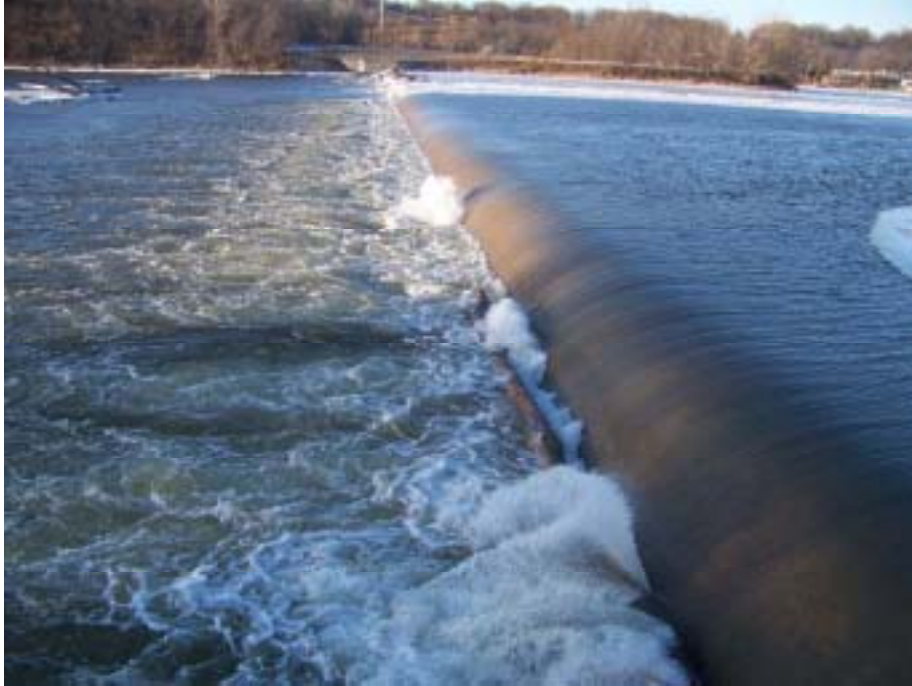
Photo 5.2.5.2 - 1 - Steel Dam, Rock River

Roller extends 5 -15' downstream from toe of dam. Note large tree trunks pinned to toe of dam, rotate occasionally.

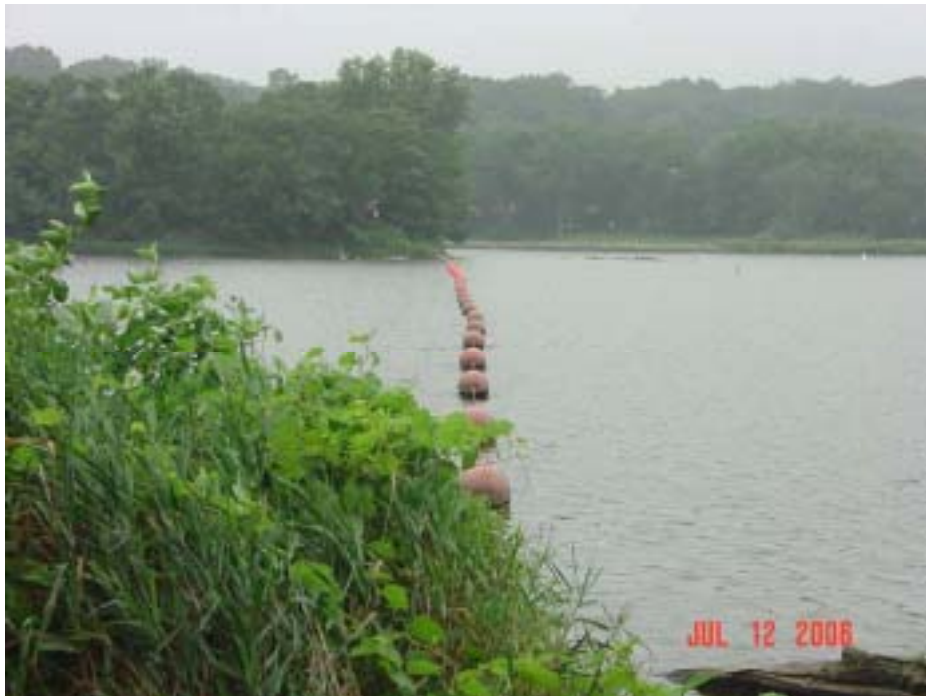
Photo 5.2.5.2 - 2 - Steel Dam, Rock River

Boatline. (IDNR, 2006)

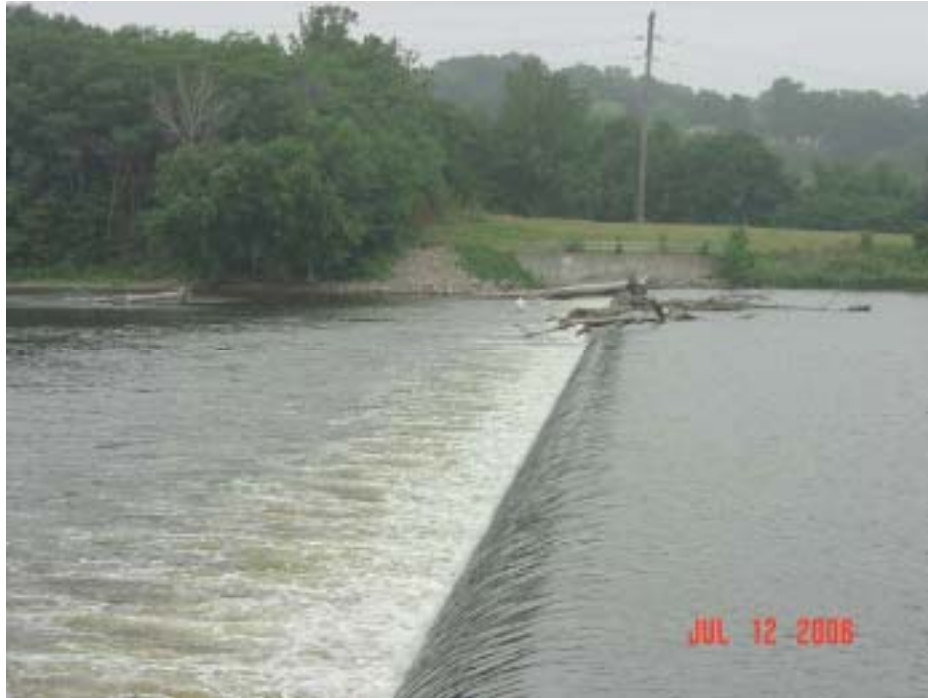
Photo 5.2.5.2 - 3 - Steel Dam, Rock River
Fisherman near roller. (IDNR, 2006)

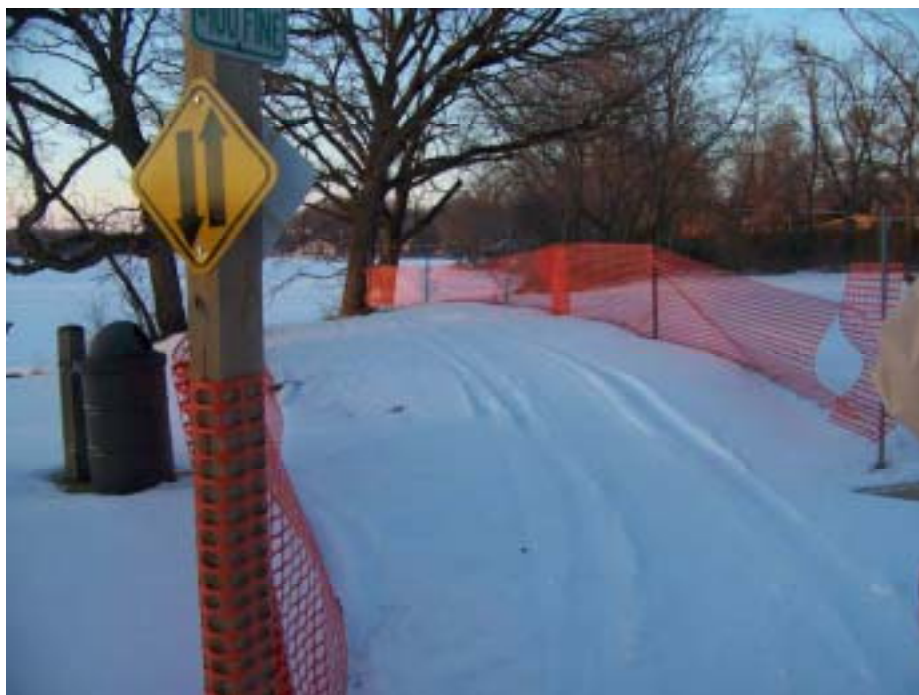
Photo 5.3.1.2 - 1 - McHenry (Stratton L & D) Dam, Fox River
Potential portage route.

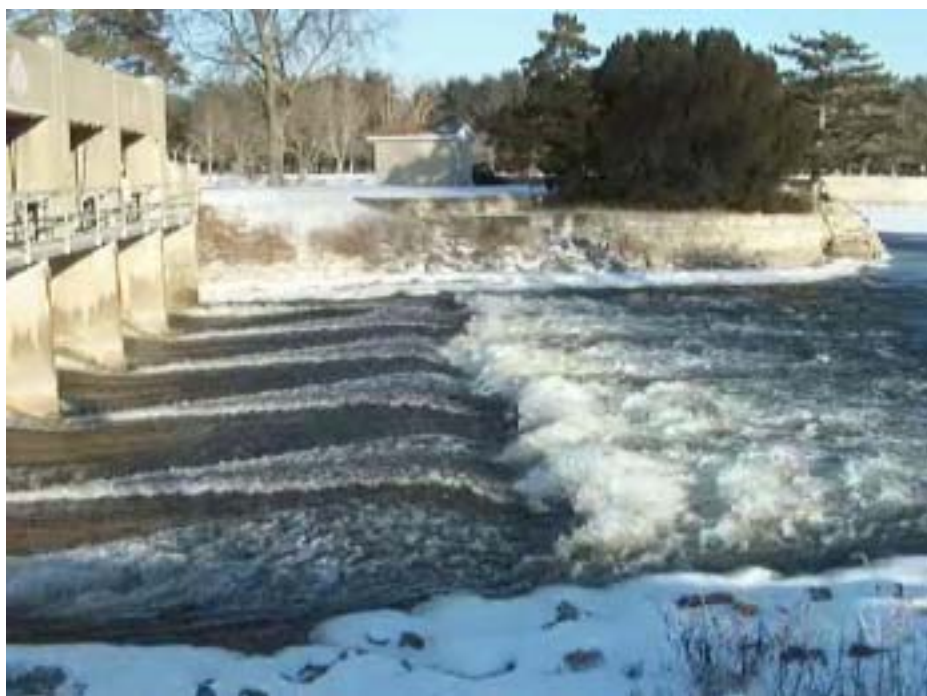
Photo 5.3.1.2 - 2 - McHenry (Stratton L & D) Dam, Fox River
Roller from right bank.

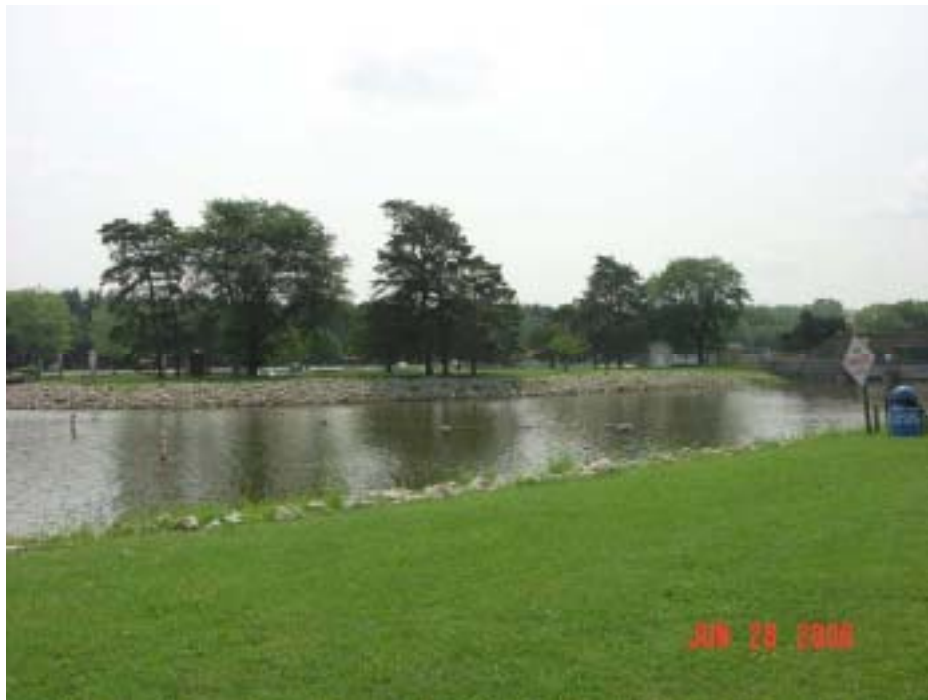
Photo 5.3.1.2 - 4 - McHenry (Stratton L & D) Dam, Fox River
Seasonal Warning Buoys, Boatline and Warning Sign. Upstream of Spillway. (IDNR, 2006)

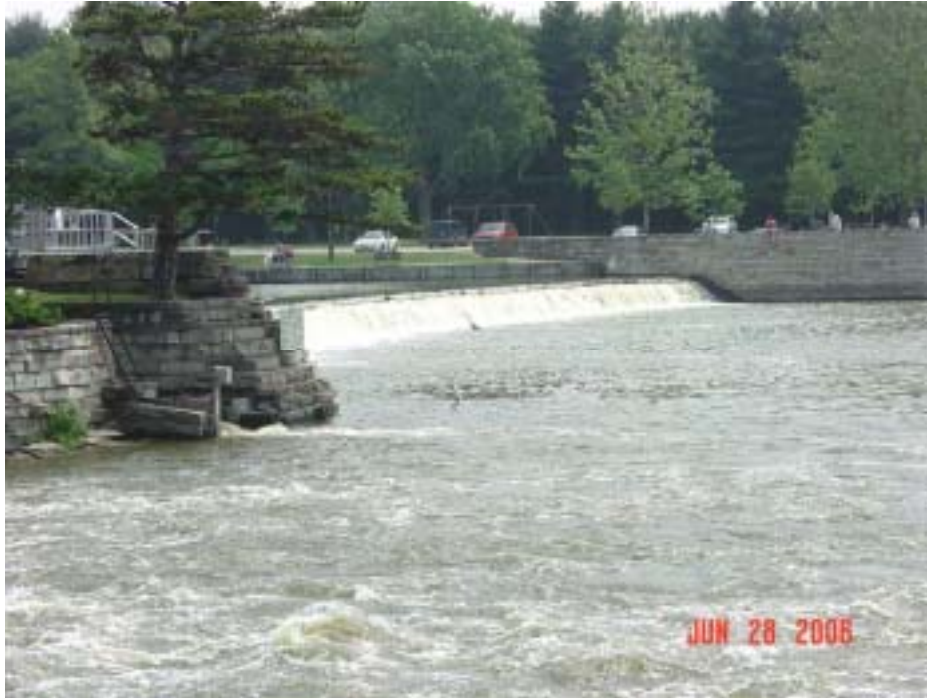
Photo 5.3.1.2 - 7 - McHenry (Stratton L & D) Dam, Fox River
Dam Face, from Downstream. (IDNR, 2006)

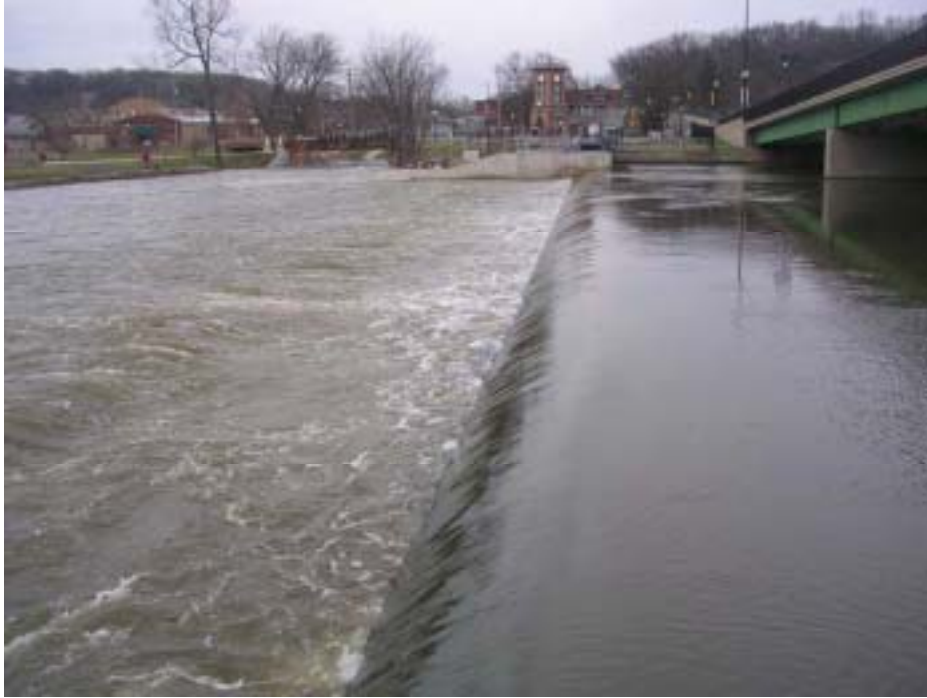
Photo 5.3.2.2- 1 - Algonquin Dam, Fox River
Dam and roller, from left bank.

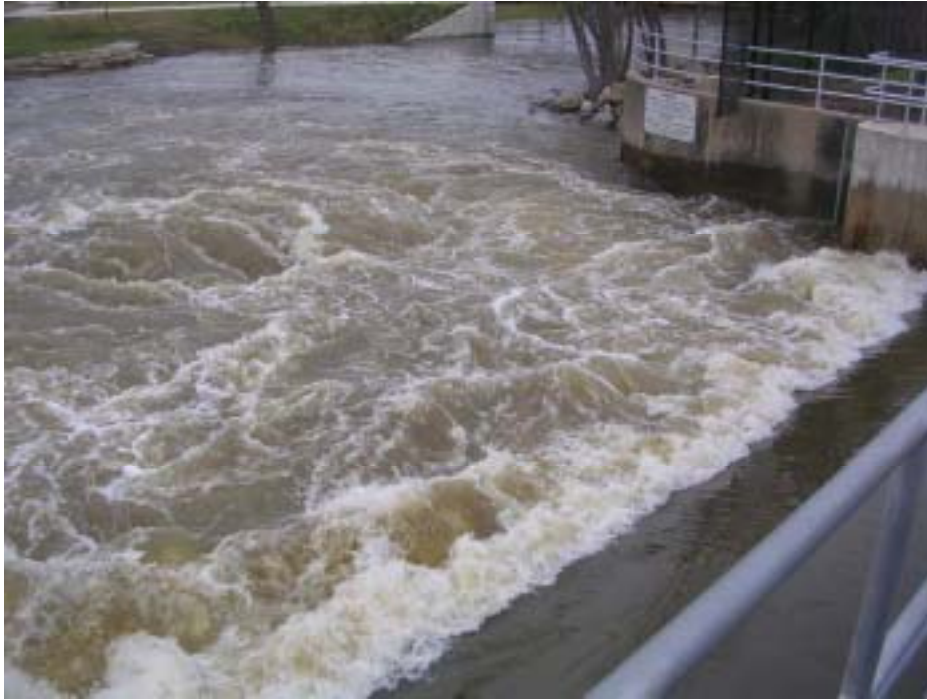
Photo 5.3.2.2- 3 - Algonquin Dam, Fox River
Spillway roller. Note warning sign and Crystal Creek mouth.

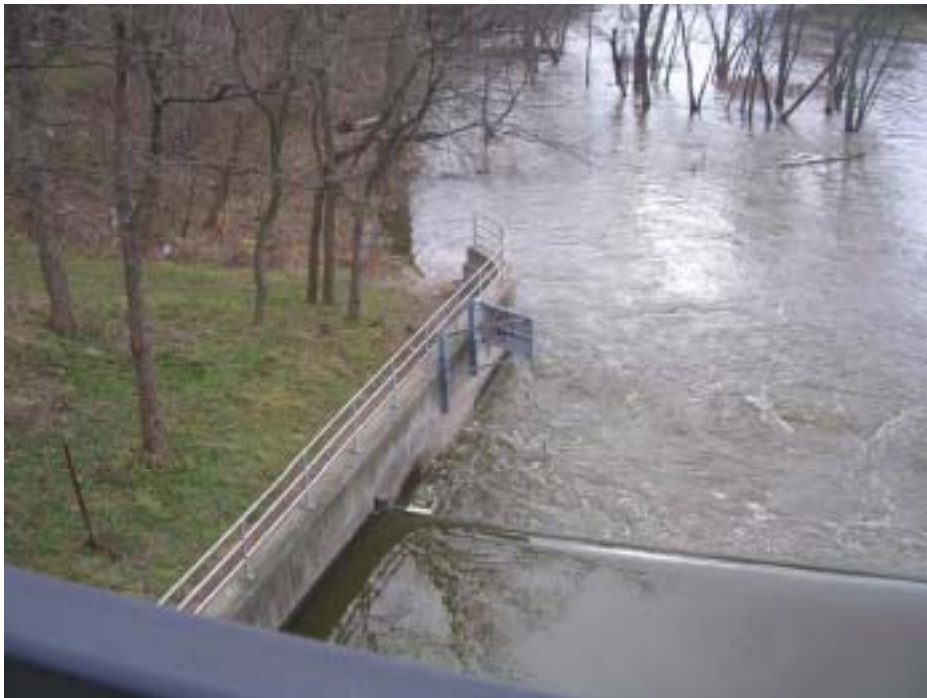
No visible obvious deficiencies were noted. The horizontal and vertical alignment of the dam crest and abutments was good. Abutments are in good condition, with 4 ft. rails. Left downstream abutment is eroded with some large rocks and steep banks.

Photo 5.3.2.2- 4 - Algonquin Dam, Fox River
View of left embankment. Area has multiple "No trespassing" signs.

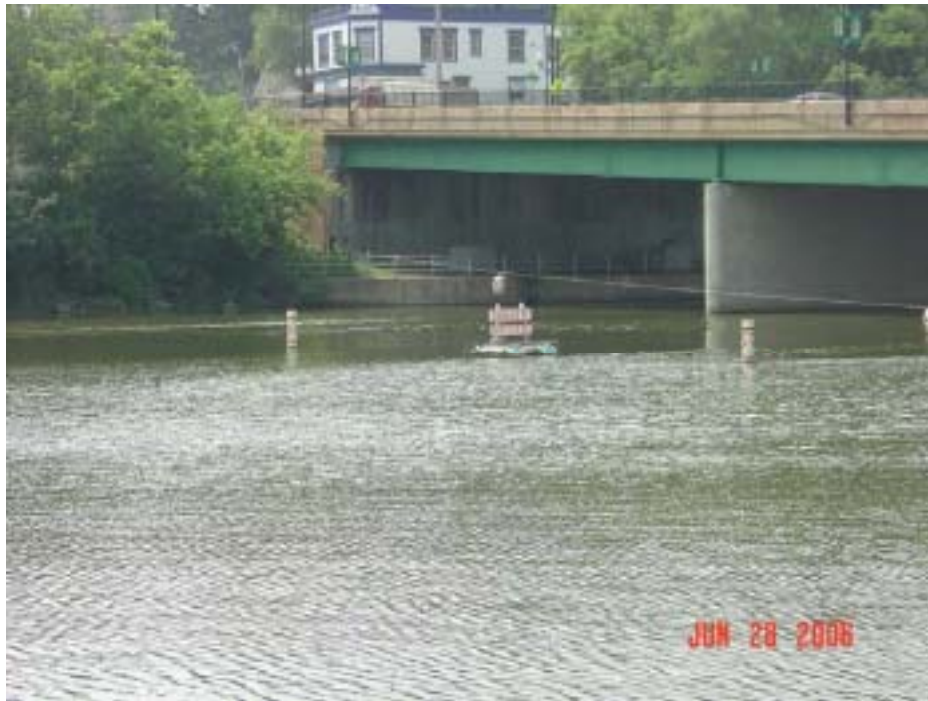
IDNR noted five (5) seasonal buoys and a floating "Danger Dam" sign upstream of the dam as shown on Figure 3.4.2.2.-1 and Photo 3.4.2.2-7.

Photo 5.3.2.2- 7 - Algonquin Dam, Fox River
Seasonal Warning Buoys and Danger Dam Ahead Sign. (IDNR, 2006)

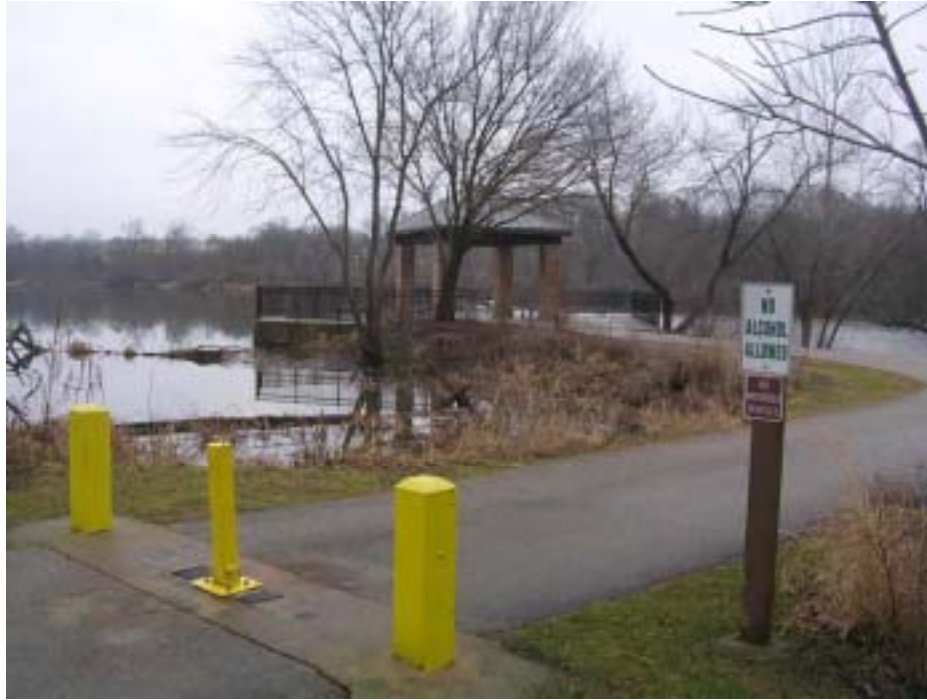
Photo 5.3.3.2 - 1 - Carpentersville Dam, Fox River
Gazebo/right abutment. Pedestrian access only.

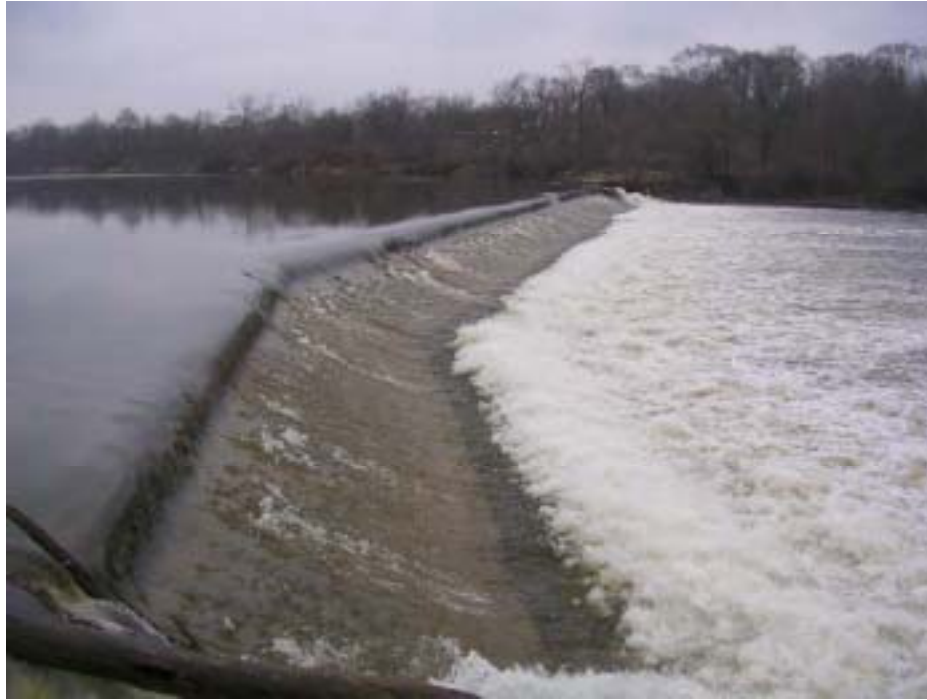
Right abutment has some undercutting at the downstream foot of the abutment. Log debris on the dam face near the right abutment was noted. Left abutment is in deteriorating condition with cracks and some vegetation growth in abutment. There is erosion around the left abutment. The fish ladder located at the left abutment showed some concrete deterioration and was partially clogged with log debris. Significant erosion on downstream left bank. There is a millrace left of the left dam abutment that has been bullheaded to prevent flow. Some overflow could occur at exceptionally high river levels. There is a pedestrian walkway over the millrace that is in poor condition. This walkway is the access to the left abutment.

Photo 5.3.3.2 - 3 - Carpentersville Dam, Fox River
View of dam face from right abutment.

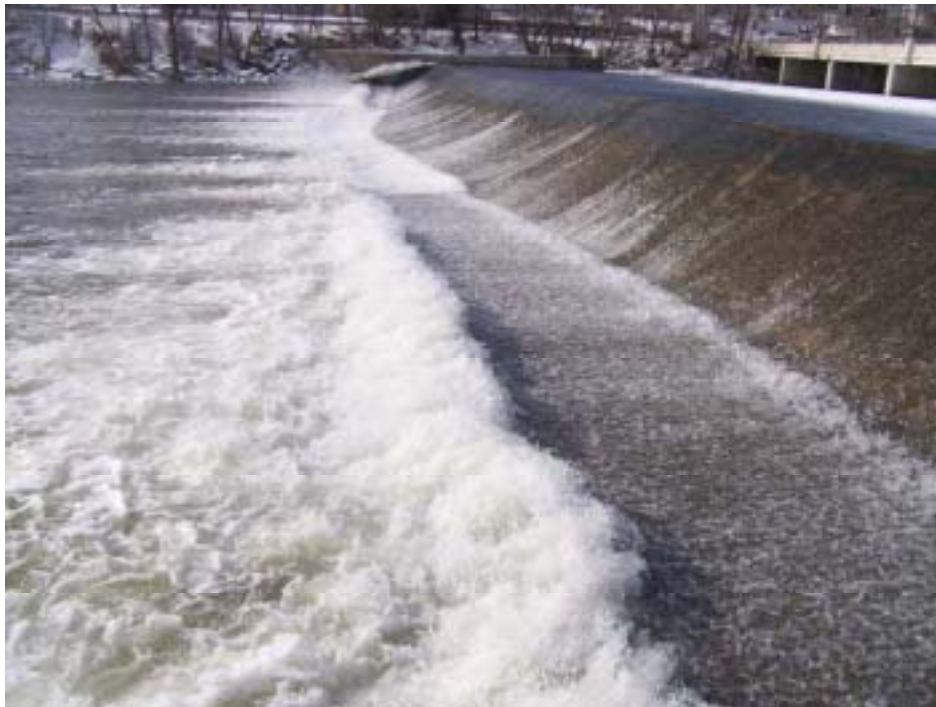
Photo 5.3.4.2 - 1 - Elgin Kimball Street Dam, Fox River
Roller from left bank

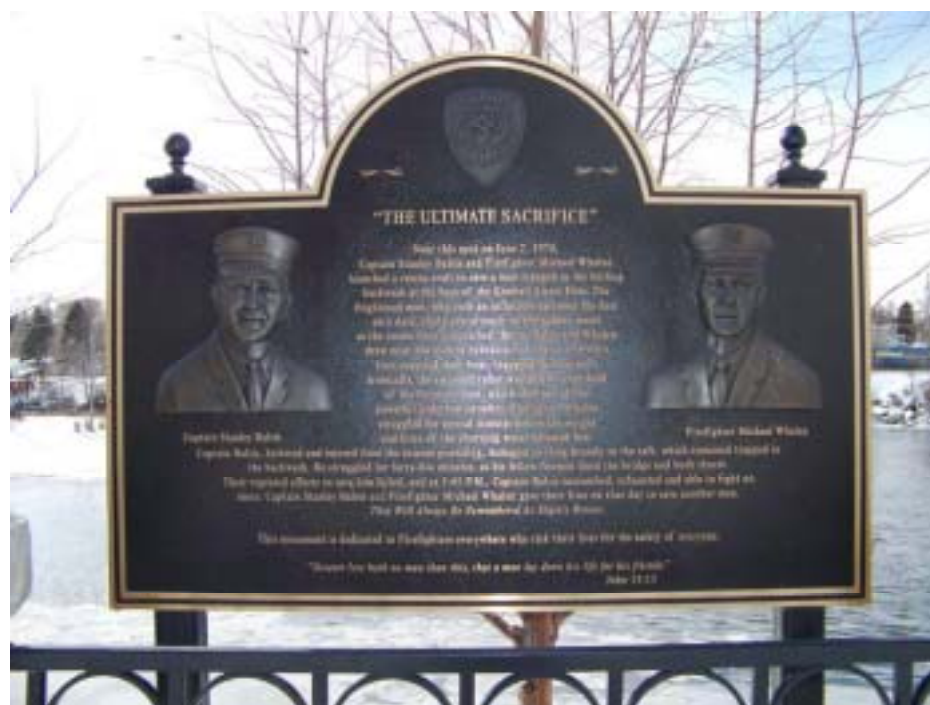
Photo 5.3.4.2 - 2 - Elgin Kimball Street Dam, Fox River
Plaque commemorating EMS workers lost in roller victim rescue effort in 1974.

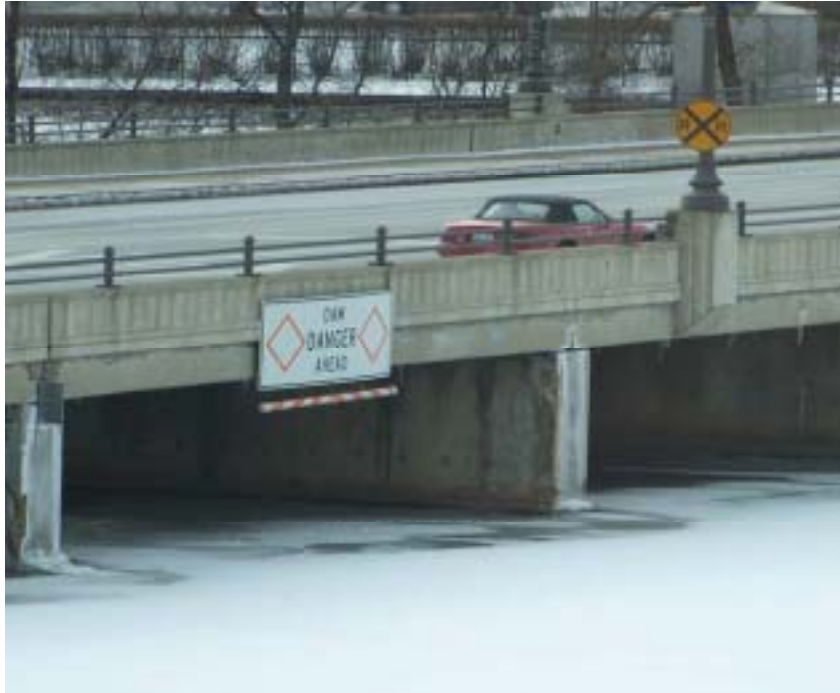
Photo 5.3.4.2 – 3 – Elgin Kimball Street Dam, Fox River
Warning sign on bridge upstream of dam

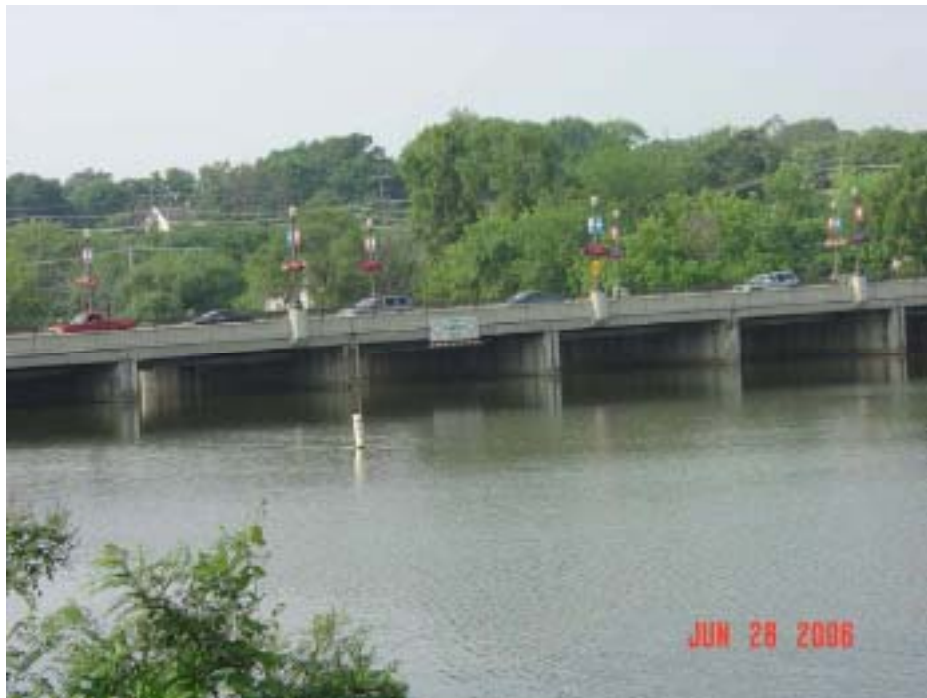
Photo 5.3.4.2 – 4 – Elgin Kimball Street Dam, Fox River
Seasonal Warning Buoys and Warning Sign on Bridge. (IDNR, 2006)

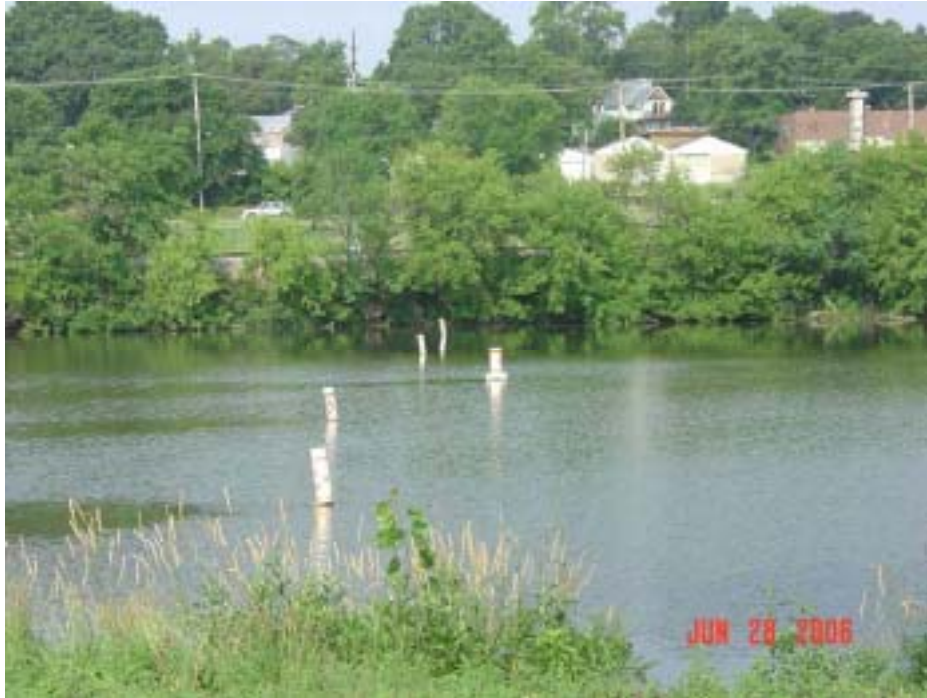
Photo 5.3.4.2 – 5 – Elgin Kimball Street Dam, Fox River
Seasonal Warning Buoys. (IDNR, 2006)

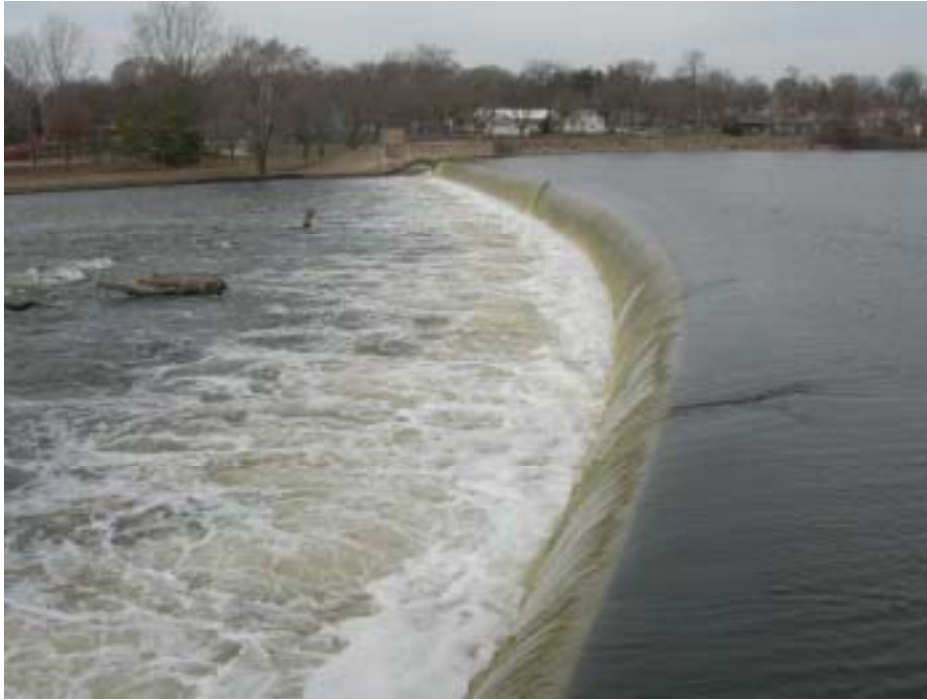
Photo 5.3.5.2 - 1 - South Elgin Dam, Fox River
View of Dam face, from left abutment. Note heavy roller.

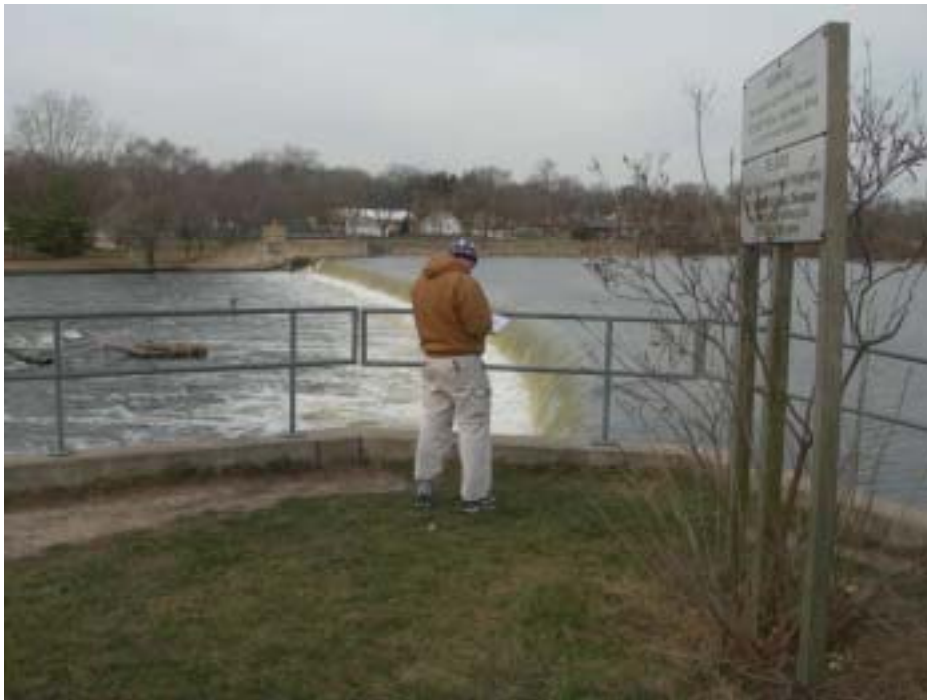
Photo 5.3.5.2 - 2 - South Elgin Dam, Fox River
Left abutment and OWR warning sign. Note large gap in Rail (24").

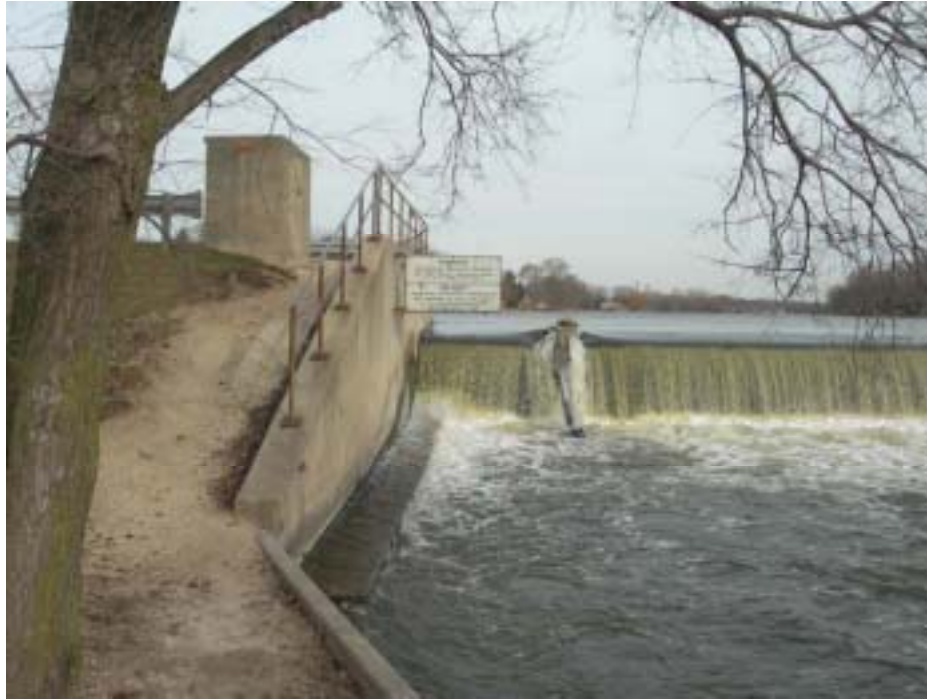
Photo 5.3.5.2 - 3 - South Elgin Dam, Fox River

Right abutment with OWR warning sign and gaging station. Note large gap in rail (24").

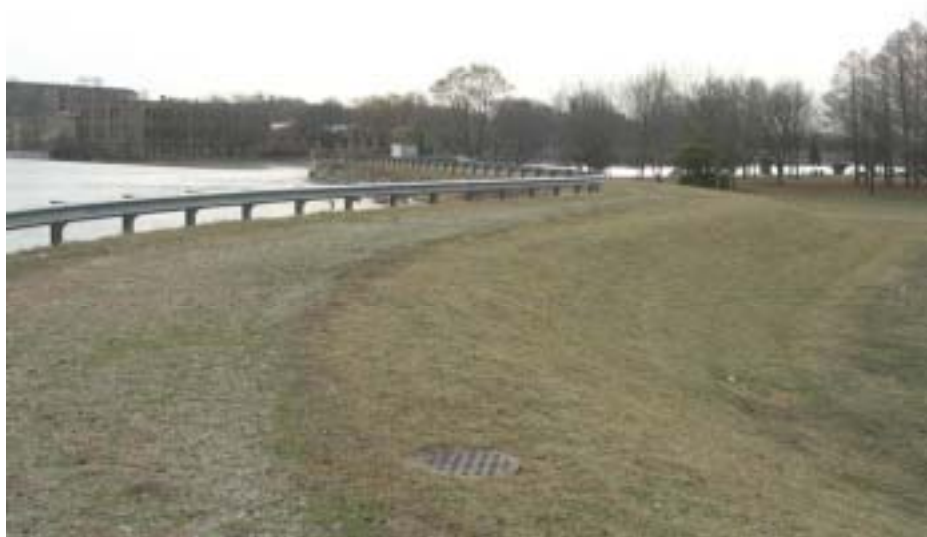
Photo 5.3.5.2 - 4 - South Elgin Dam, Fox River

Emergency Access road on right abutment. Potential area for creation of portage point.

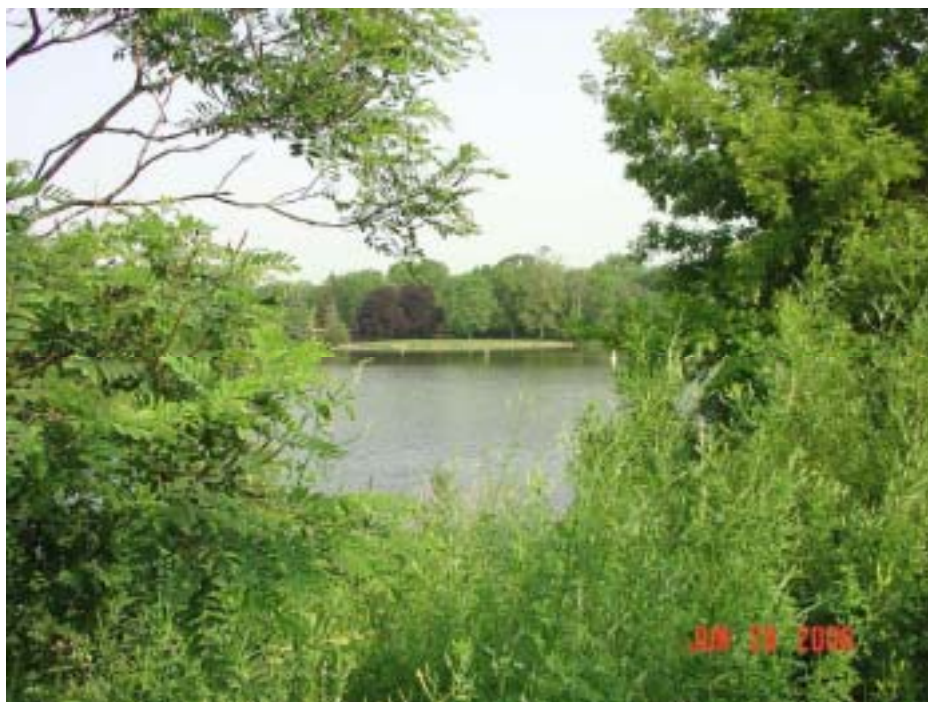
Photo 5.3.5.2 - 5 - South Elgin Dam, Fox River
Seasonal Warning Buoys (IDNR, 2006)

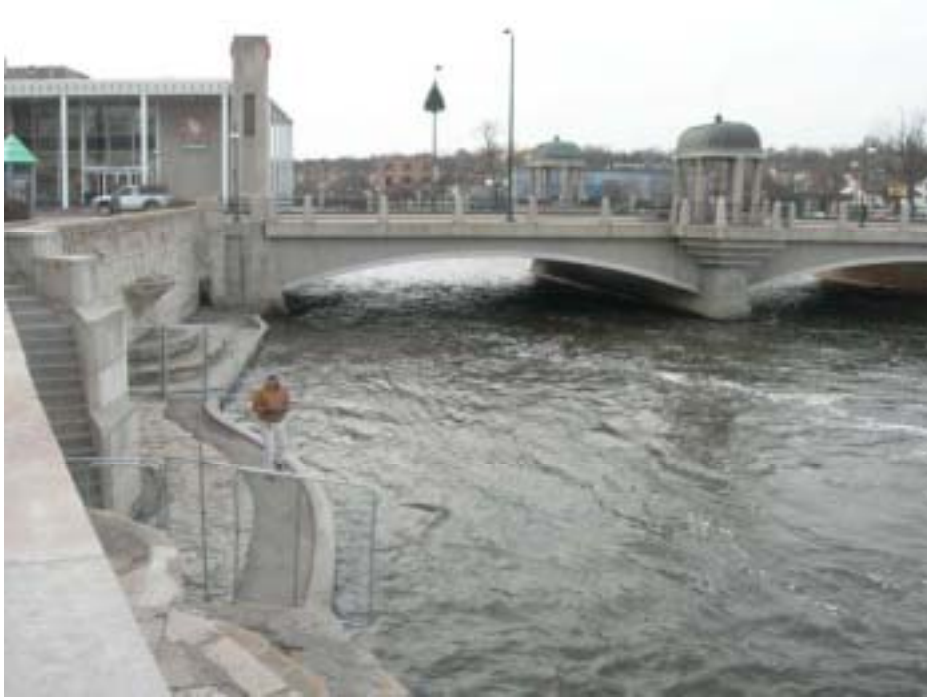
Photo 5.3.6.2 - 3 - St. Charles Dam, Fox River

Downstream left bank, looking downstream. Stairs/portage and boat launch on left bank.

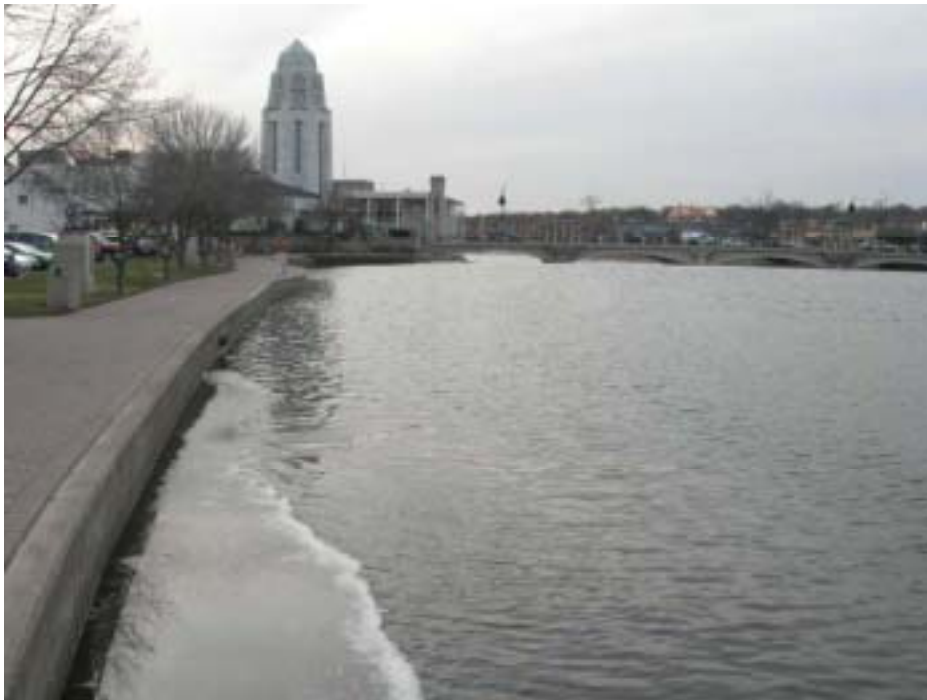
Photo 5.3.6.2 - 4 - St. Charles Dam, Fox River

Upstream left bank, looking downstream. Canoe portage area along on 2-3' ledge.

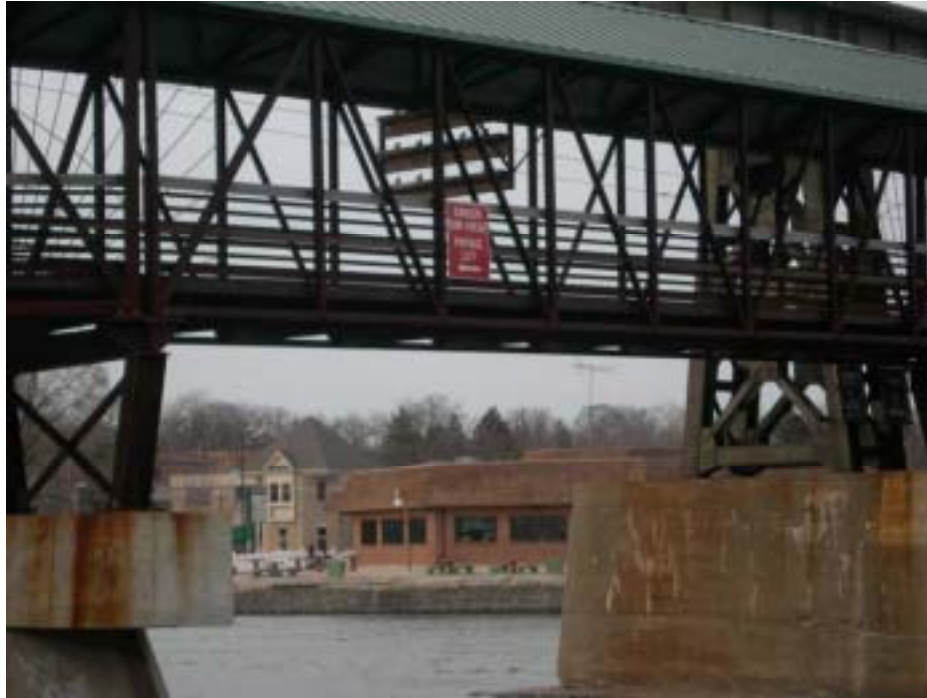
Photo 5.3.6.2 - 5 - St. Charles Dam, Fox River

Upstream pedestrian bridge. 2 signs on bridge: "Danger Dam Ahead, Portage left". Also 2 small green warning signs indicating dam and portage to left.

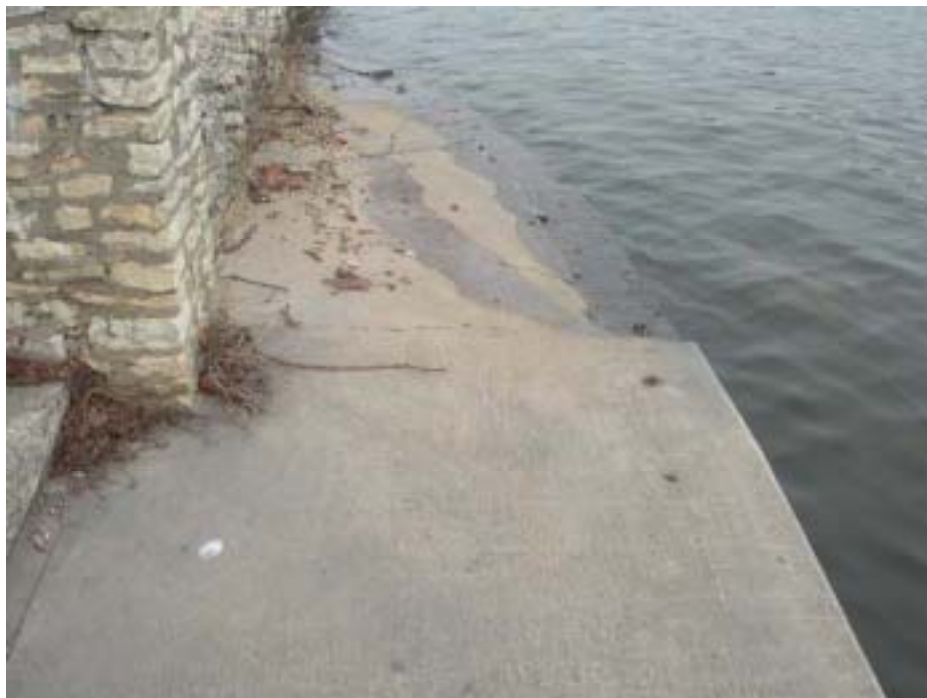
Photo 5.3.6.2 - 6 - St. Charles Dam, Fox River

Upstream right bank. Boat launch/Canoe Portage.

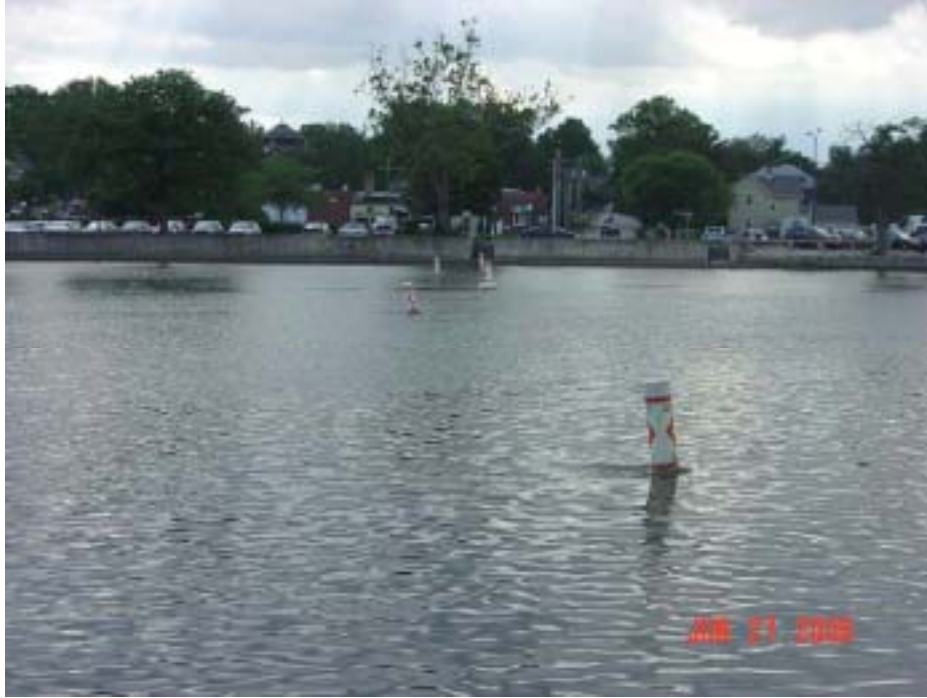
Photo 5.3.6.2 - 7 - St. Charles Dam, Fox River
Seasonal Warning Buoys, from left bank. Note stairs and portage on right bank.
